Duan, G., Shu, A., Rubinato, M. orcid.org/0000-0002-8446-4448 et al. (2 more authors) (2018) Collapsing mechanisms of the typical cohesive riverbank along the Ningxia-Inner Mongolia catchment. *Water*, 10 (9). 1272. ISSN 2073-4441

Collapsing Mechanisms of the Typical Cohesive Riverbank along the Ningxia–Inner Mongolia Catchment

Guosheng Duan ¹, Anping Shu ^{1,*}, Matteo Rubinato ²

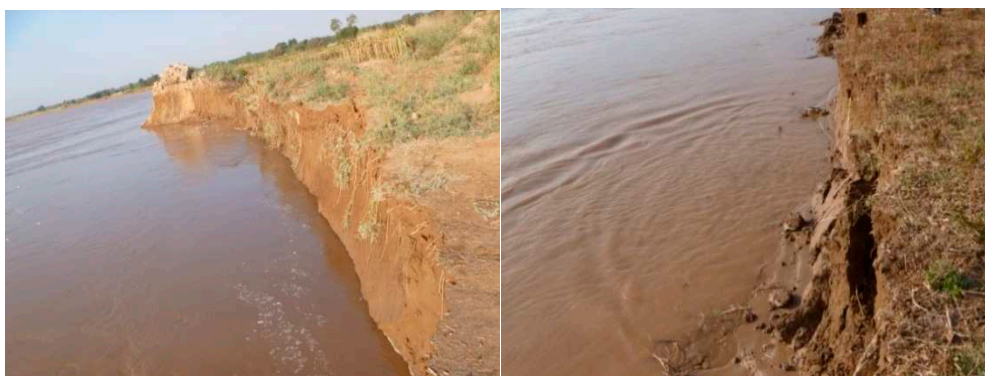
Figure 3. Example of the existing bank slope (**left**) and an example of riverbank collapse along Dengkou reach (**right**).

When collecting field data, observations were made to get more insights about the erosion that typically affects the riverbanks of the Ningxia–Inner Mongolia catchment. Figure 3 shows an example of the real case study under investigation prior and after the erosion. Observations confirmed that the bank material is cohesive, the riverbank slope is steep (77–86°), and the pattern of bank collapse is considered to be planar, in conformity with previous studies conducted [48,49]. Additionally, while monitoring the site, it was possible to identify different stages of the continuous collapse process characterized as follows: (i) the bank toe erosion initiates (Figure 4a); (ii) tension cracks develop (Figure 4b); (iii) shearing starts and parts of the bank breaks and detaches from the main body (Figure 4c); (iv) bank failure occurs (Figure 4d). When the soil collapses from the bank, part of it is washed away by the water and the remaining part accumulates at the bank toe. The new shape of the bank including the additional material eroded then becomes the initial form of the next bank collapse.
